Practical Experience with Remediation of a Former Active Handling Building Site in the United Kingdom - 9058

J Armitage and R M Cornell, Nuvia Limited
and
A Staples, United Kingdom Atomic Energy Authority (UKAEA)
All located at
UKAEA Winfrith Site, Dorchester, Dorset, United Kingdom

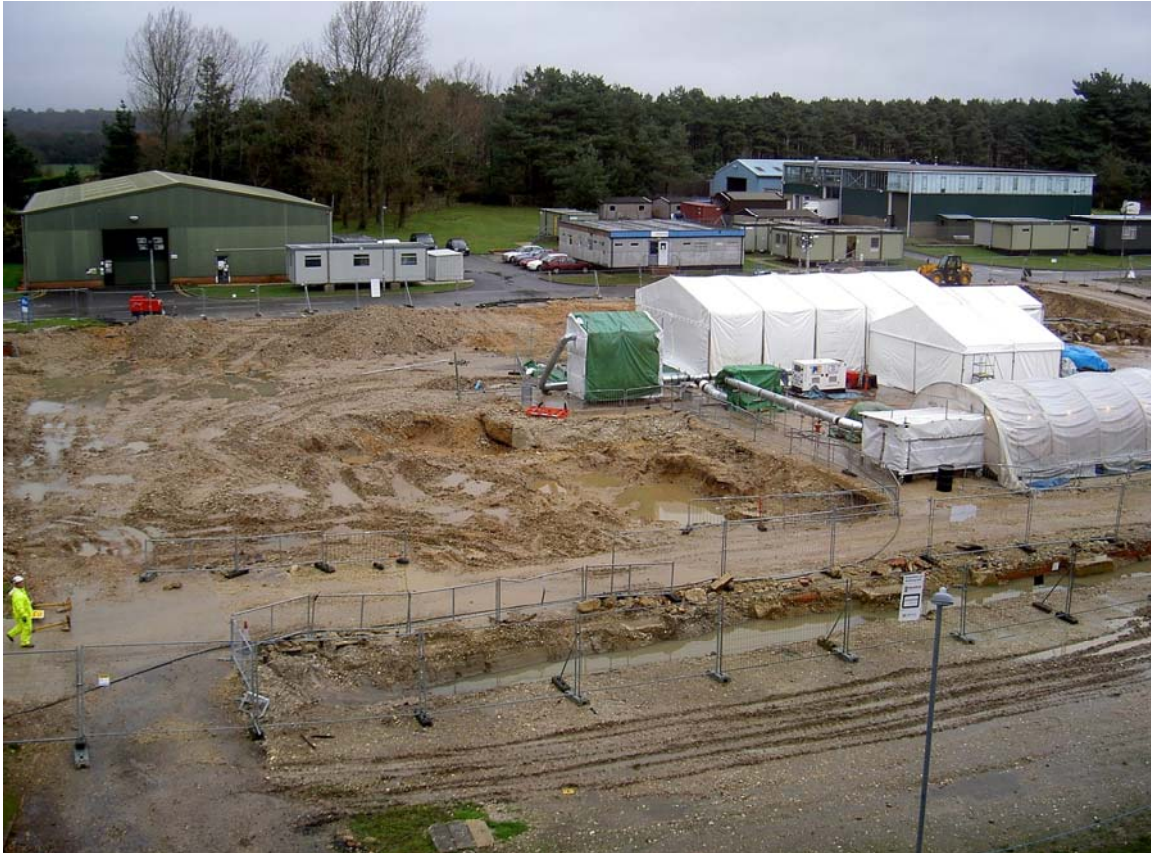
Figure 2: Ventilated Enclosures over NCL and Decontamination Bay Sump Areas also showing the Zone 1 area cleared of concrete to left side. Note also the presence of groundwater in puddles after rain due to clay content of the soil

The materials recovered from the base slab demolition mainly comprised broken high and low density concrete and contaminated steel items such as the mortuary tubes. However some clean steel materials were also recovered, mainly the reinforcing bars used in the upper layers of concrete and various foundation materials. These latter materials were recovered and set aside for monitoring and, if appropriate, recycling. The concrete was initially pulverised using another hydraulic breaker to a 75mm cube or smaller. In many cases a concrete crushing machine was also used for this purpose and all size-reduced materials placed into 1te builders' bags for temporary on-ground storage. The excavator was used to recover all concrete materials from this first area of the base slab such that only the underlying soil remained, Figure 2.

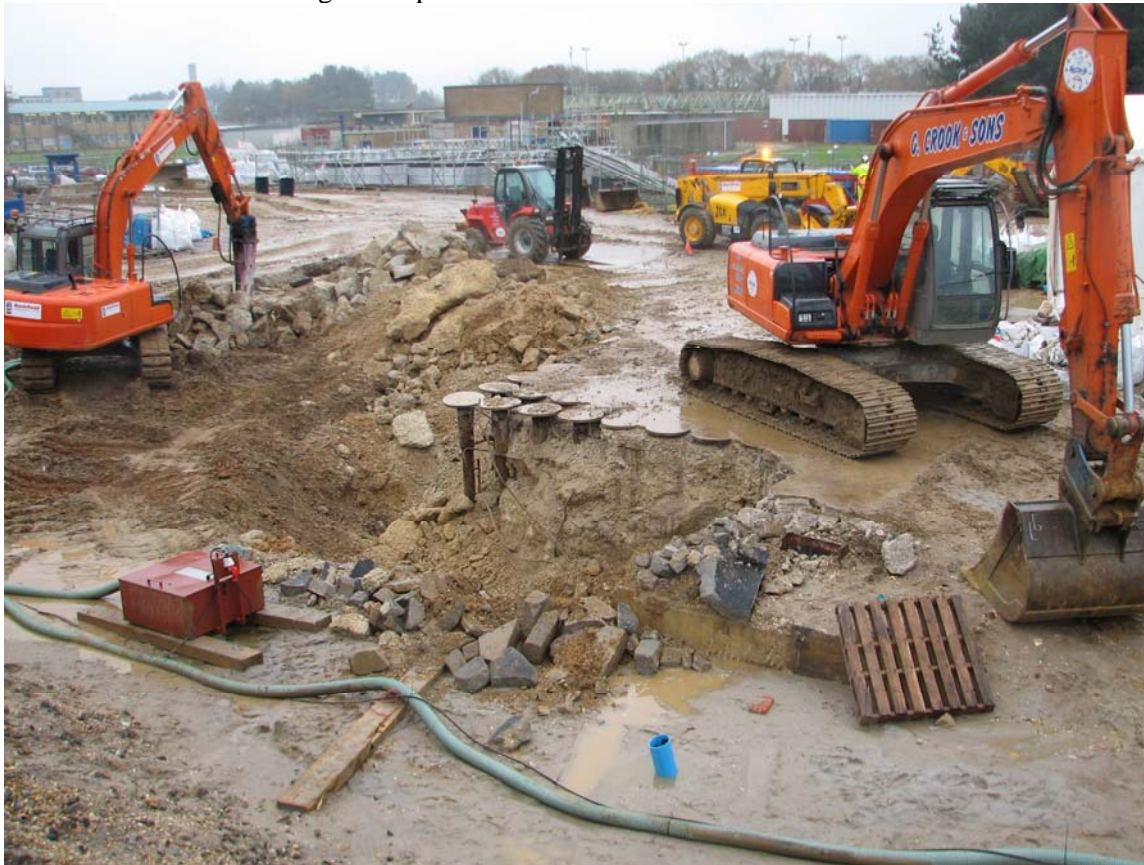
Figure 3: Recovery of deep mortuary tubes from base slab close to dewatering well

these materials. This was undertaken to establish a safe angle of attack for the excavations such that the sides would remain stable during recovery operations. Following these tests and subsequent discussions with experts, a safe but more practical means of the recovery of these tubes was devised, minimising the quantities of soil that were required to be removed. Figure 3 shows a typical view of one of these excavations.

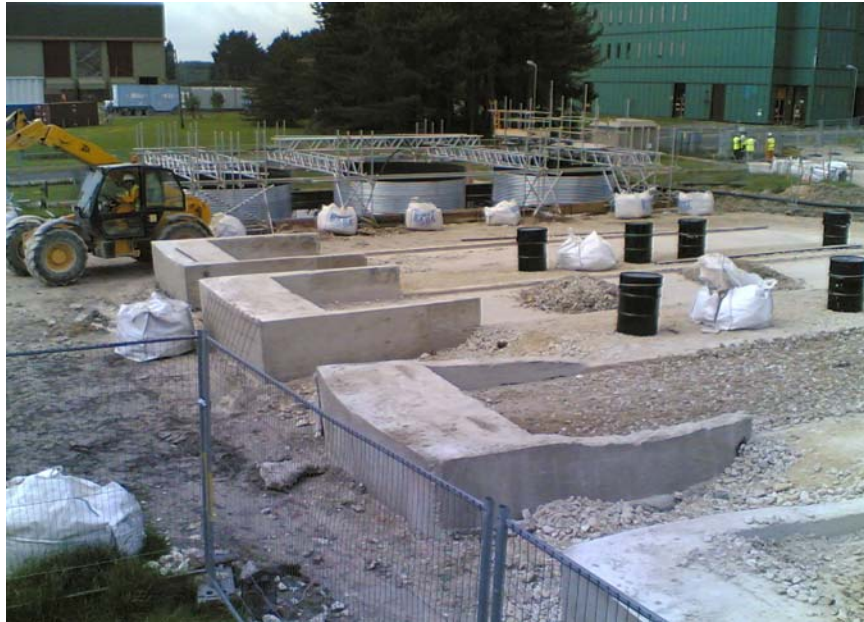
Figure 4: Monitoring of concrete debris in the external troughs with LLW drums ready for removed materials with dewatering tanks in the background.

The concrete monitoring procedure has previously been described (References 6 & 8), but in outline comprises two separate but complementary procedures. Firstly, the materials in the bags, having already been crushed to <75mm cube, were emptied out and ‘trough monitored’ in a low radiation background area of the demolition site. Four concrete lined troughs 2.5m wide, 15m long and 0.1m deep had been constructed upon a section of the demolition site for this purpose, (Figure 4).

The monitoring process, which uses a 3” (76mm) NaI detector and count rate meter to identify and assist with removal of any materials above an agreed background count rate, identifies bulk concrete that may be suitable for disposal to landfill as exempt waste. Some of the material was set aside in the Winfrith rubble store for use as infilling when various large structures on site are demolished at some time in the future. However, the majority of this material was sent for disposal at a local landfill.

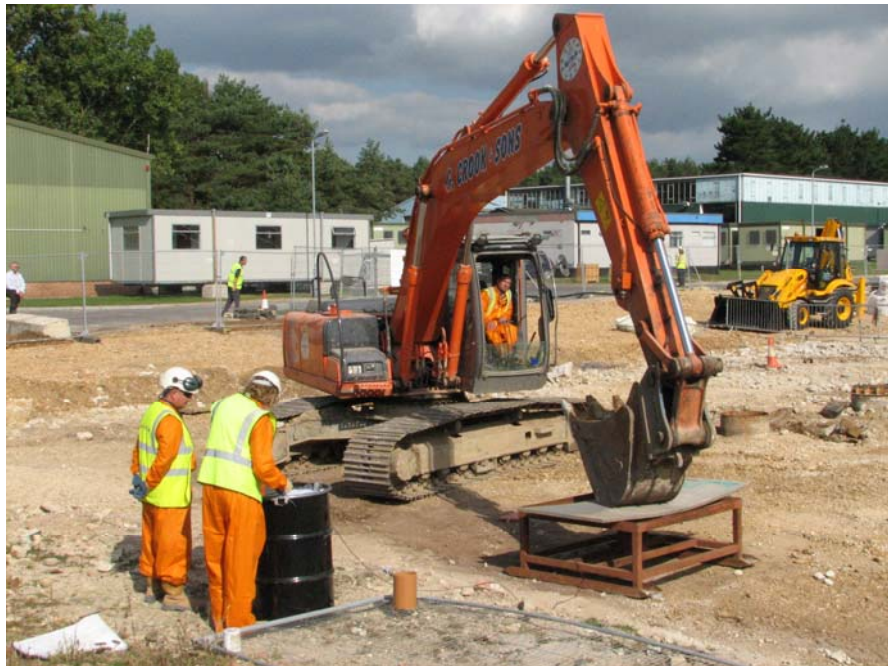
Figure 6: Bucket Monitoring of Soils using Table & Sodium Iodide Detector

bucket to remove progressive layers of soil for checking for activity using a well-established bucket-monitoring process. Here the ~0.5m³ bucket of the machine, Figure 6, is loaded with soils and placed upon a reference table set over a NaI 76mm detector system. This system is set up and calibrated to give a go/no-go response so that the soil can be set aside for reuse or bagged for more detailed monitoring if contamination is suspected ahead of any disposal considerations.
